NOBLIN & ASSOCIATES, LLC

RESERVE BUDGET ANALYSIS CHAPEL HILL WEST CONDOMINIUM FRAMINGHAM, MASSACHUSETTS PROJECT #18.10.511

DATE: January 18, 2019

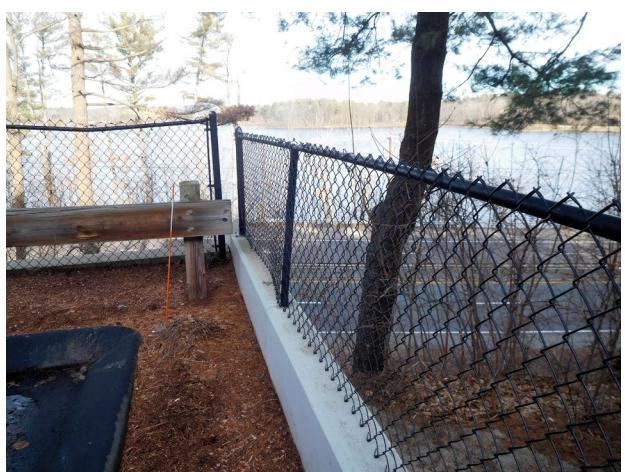
Fencing - Fencing around the property includes chain link fences on the concrete retaining walls near the front of the property, which are in fair condition, and metal fencing around the pool perimeter, which is in good condition (Photographs 2 & 3). An allowance of \$9,300 has been included in 2034 for replacement of the chain link fencing, and an allowance of \$13,950 has been included in 2045 for replacement of the pool fence.

Photograph 2 - View of the chain link fence.

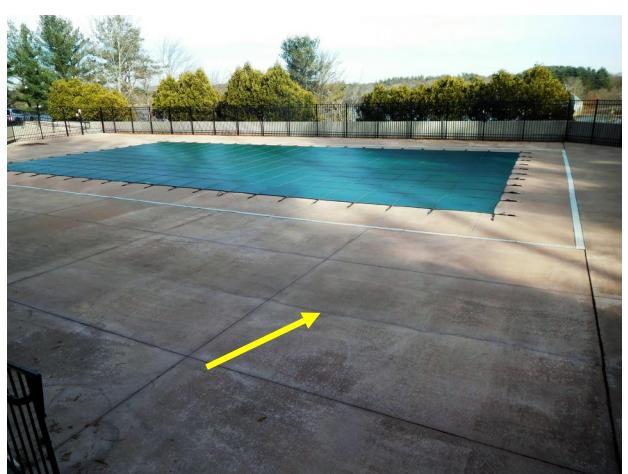
Photograph 3 – View of the pool area with the perimeter metal fence in the background. Note the crack in the concrete pool deck (arrow).

Pool Allowances have been included for refurbishment of the pool area surfaces. These include replacement of the coping (\$8,000 in 2039), replacement of the Surfaces concrete pool deck (\$101,580 in 2031), and restoration of the pool inner surfaces (\$30,000 in 2038).

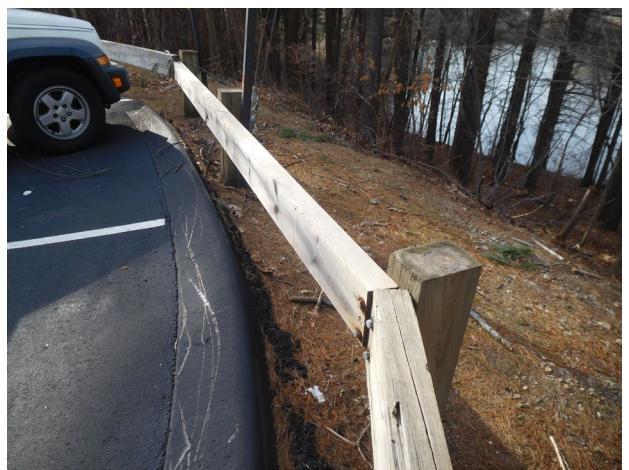
Guardrails - Steel and wood guardrails are located along the edge of the north and east sides of the parking area. The wood guardrail is in good condition and the steel guardrail is in fair condition (Photographs 4 & 5). Allowances of \$12,400 in 2043 and \$5,600 in 2029 have been included for replacement of the wood and steel guardrails, respectively.

Photograph 4 – Example of the wood guardrail.

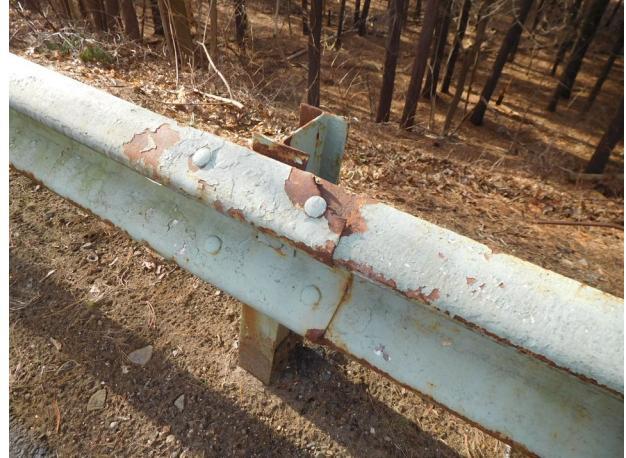
Photograph 5 – Example of the steel guardrail.

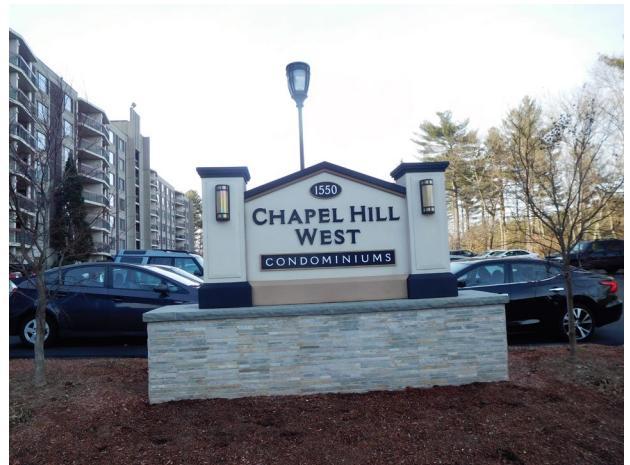
Main Sign-The main property sign is located at the east end of the parking area, which is in good condition (Photograph 6). An allowance of \$4,000 has been included for refurbishment of the sign and base in 2027.

Photograph 6 – View of the main sign.

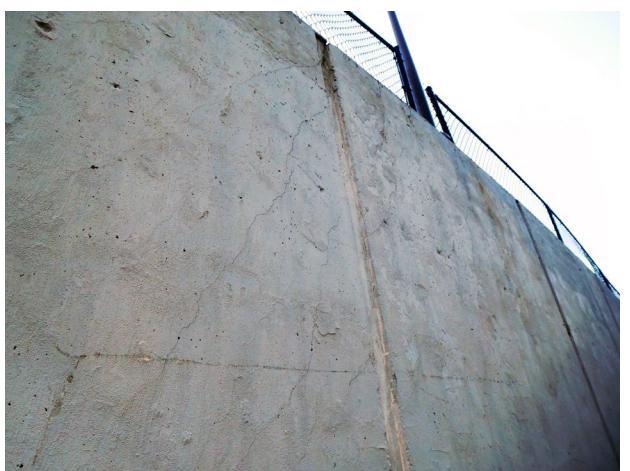
Photograph 7 – Diagonal cracks near the outside corner are indicative of structural deterioration.

Retaining A cast-in-place concrete retaining wall is located along the south side of the main Walls entrance ramp. This wall has been slowly deteriorating for more than a decade and has been regularly monitored. It is showing signs of severe deterioration (Photograph 7) and its replacement should be anticipated in the near future. An allowance of \$500,000 has been included in 2022 for replacement of the wall.

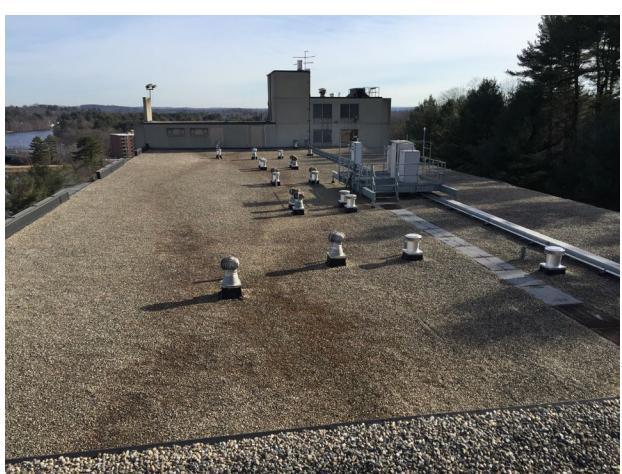
- Main Roof -The main roof consists of a Tremco gravel surfaced, built-up asphalt roof system, which was installed in 2000 (Photograph 8). At the time of our review, the roof and visible flashings appeared to be in serviceable condition and no significant deficiencies were reported. An allowance of \$576,086 has been included in 2020 for replacement of the roof. Reroofing with a single-ply membrane adhered to thermal insulation underlayment has been assumed. Reroofing is assumed to include removal of the existing roof system to allow inspection of the underlying structural deck.
- Cabana The cabana roof was replaced in 2016 with a new asphalt shingle roof. An Roof allowance of \$3,955 has been included in 2041 for replacement of the shingle roof.

Photograph 8 – View of the main roof.

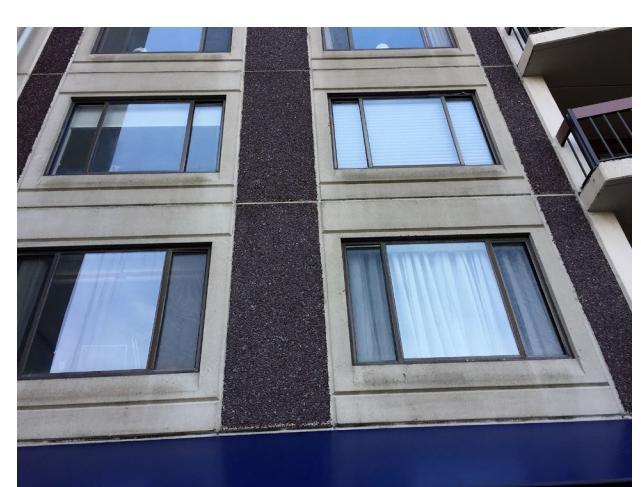
Photograph 9 – Example of the exterior wall concrete panels.

- Exterior The exterior wall system on the building (consisting of large precast concrete panels) is constructed as a barrier wall system (Photograph 9). This type of construction is intended to form a complete waterproof skin to prevent water infiltration beyond the exterior surface of the wall. The panels are vulnerable to water infiltration through their joints and any cracks that may develop. An annual allowance of \$3,000 has been included for repair of cracks and an allowance of \$175,000 has been included for regular replacement of joint sealant with the next iteration in 2027.

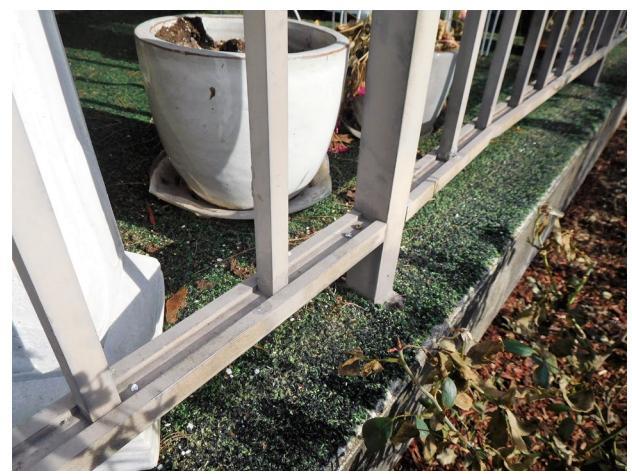
- Balcony The balconies are provided with aluminum railing systems with wood board top rails (Photographs 10 & 11). The wood and aluminum components are in fair condition. An allowance of \$182,000 has been included in 2023 for complete replacement of the railings.

Photograph 10 – Example of typical aluminum balcony railing components.

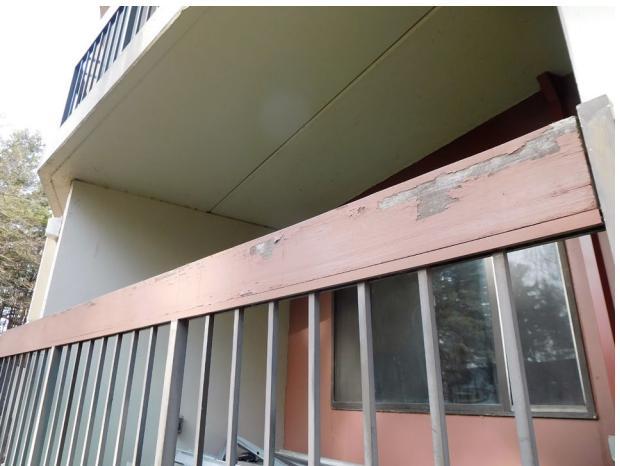
Photograph 11 – Example of a typical balcony wood top rail.

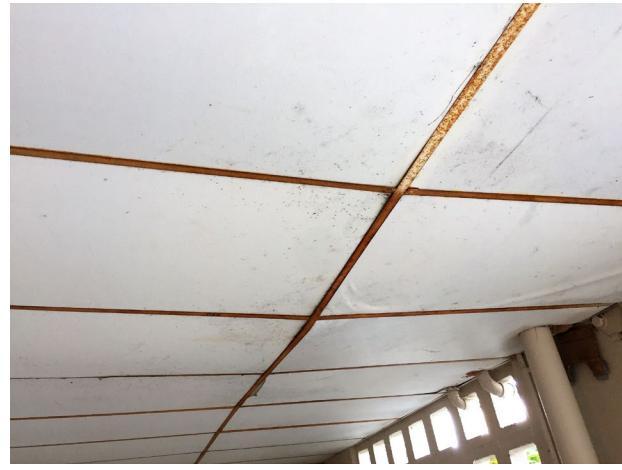
- Garage The ceilings in the garages are finished with acoustical panels in metal frames.
- Ceilings Many panels have been water damaged and the frame is corroded in most locations (Photograph 12). An allowance of \$171,000 has been included in 2020 for replacement of the garage ceilings.

Photograph 12 – Example of a deteriorated garage ceiling area.
